# The Northern Chaco Outliers Project Annual Report, 2017 Field Season

*Rebecca L. Simon, Susan C. Ryan, Shanna R. Diederichs, Kari L. Schleher,  
Caitlin A. Sommer, Steven R. Copeland, and Grant D. Coffey*

This report summarizes progress on the NCOP during Crow Canyon’s 2017 field season, which was conducted from March through October. This research was funded in part by a History Colorado State Historical Fund grant (No. 2016-02-035) and a grant from the Earthwatch Institute. Fieldwork and associated Crow Canyon education programs were conducted by members of Crow Canyon’s archaeology and education staffs with the assistance of interns. Field and laboratory studies conducted by contractors are also summarized in this report. Upon completion of all fieldwork, laboratory analyses, and synthetic studies related to the NCOP, Crow Canyon will publish detailed results of this research on its web site ([www.crowcanyon.org](http://www.crowcanyon.org)).

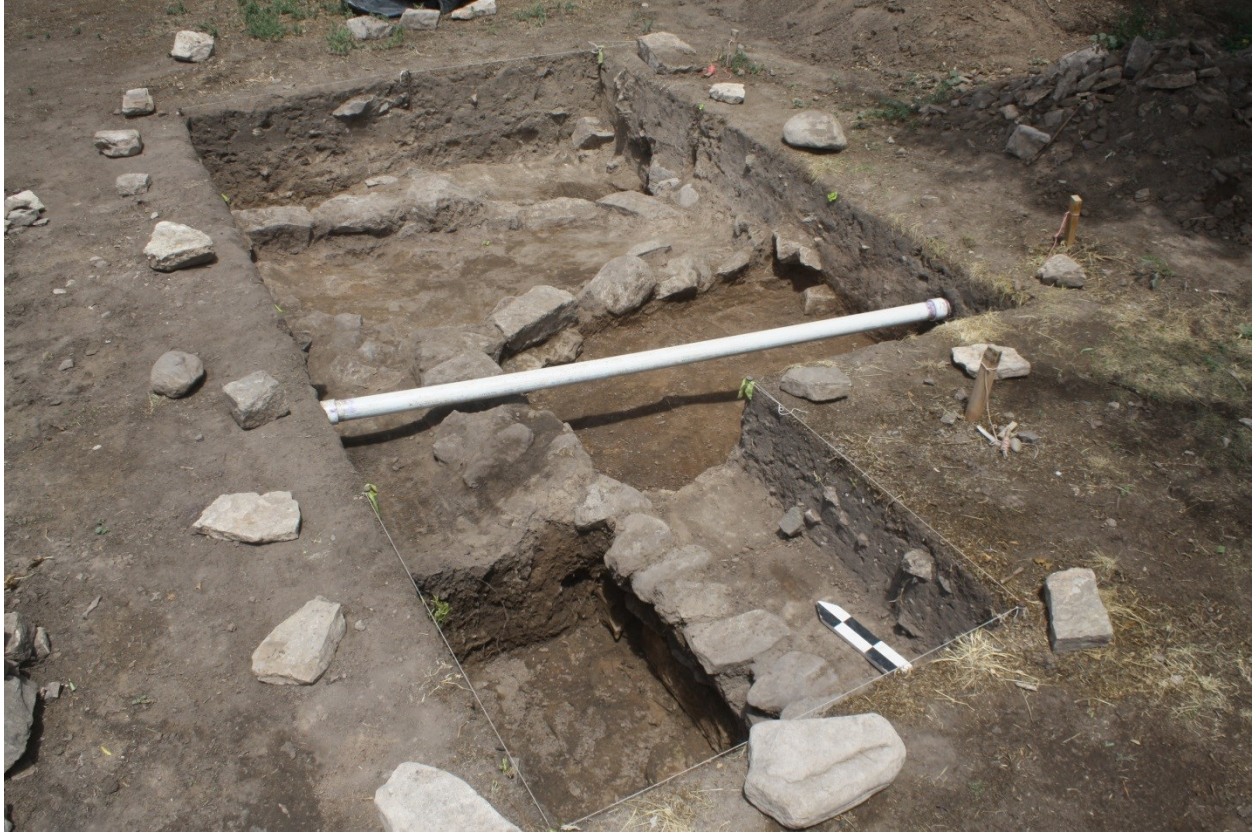
**Figure 5. Excavation in progress of wall and roof fall in Structures 186 and 193 (view northeast), the Haynie site.**

Located west of the modern house, Structure 186 (Figure 5 and Figure 6) is a room featuring single-coursed masonry. A wall segment, which was identified in a 2-x-2-m unit and a 1-x-1-m unit, had been constructed using irregularly shaped sandstone rocks and mortar. The installation of a modern laundry-drainage pipe had damaged the wall and disturbed the fill in the room. Structure 186 appears to be a detached room constructed within, and possibly using the remains of, an earlier structure (Structure 193). The floor is unplastered construction fill. We infer that the remainder of the room is damaged and that the damage was caused by the roots of a nearby apple tree and by additional activities related to modern occupation. Excavations will continue in this structure in 2018.

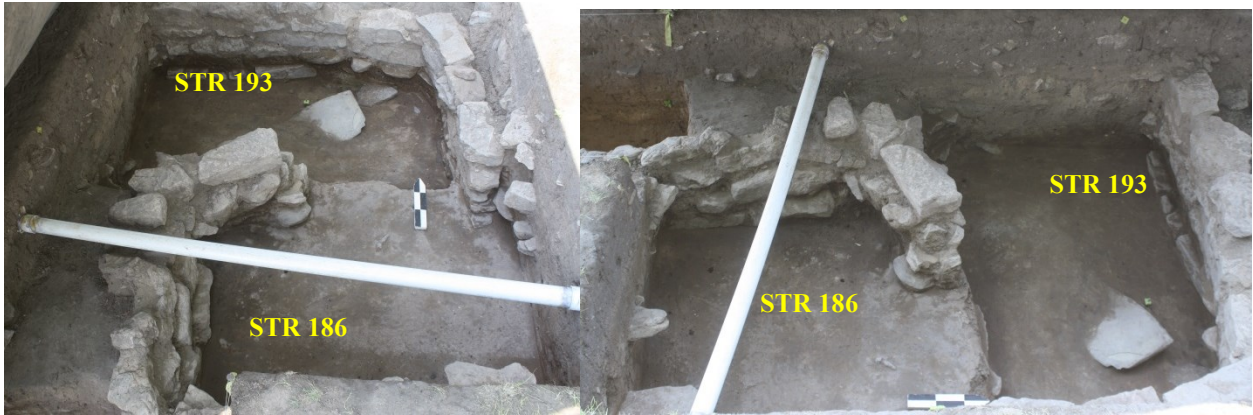
**Figure 6. North and west oblique views of Structures 186 and 193, the Haynie site.**

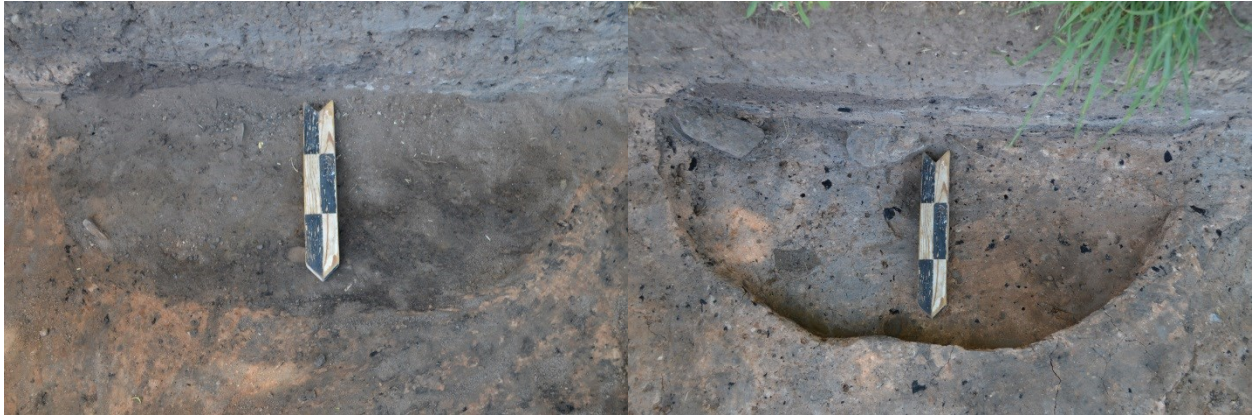
**Figure 7. Pre- and post-excitation, Feature 1, Nonstructure 187 (view south), the Haynie site.**

Nonstructure 187 is a surface identified in a 2-x-2-m unit. This surface had been created in a deposit of construction material that was impacted by mechanical disturbance and by the installation of a modern irrigation system in the western portion of the unit. A pit feature, Feature 1 (Figure 7), had been dug into this surface. The top of the feature had also been disturbed by mechanical activity in the west great house and by the creation of the modern lawn (Figure 8). The few artifacts collected from Feature 1 included sherds, flaked-lithic debitage, and nonhuman bone.

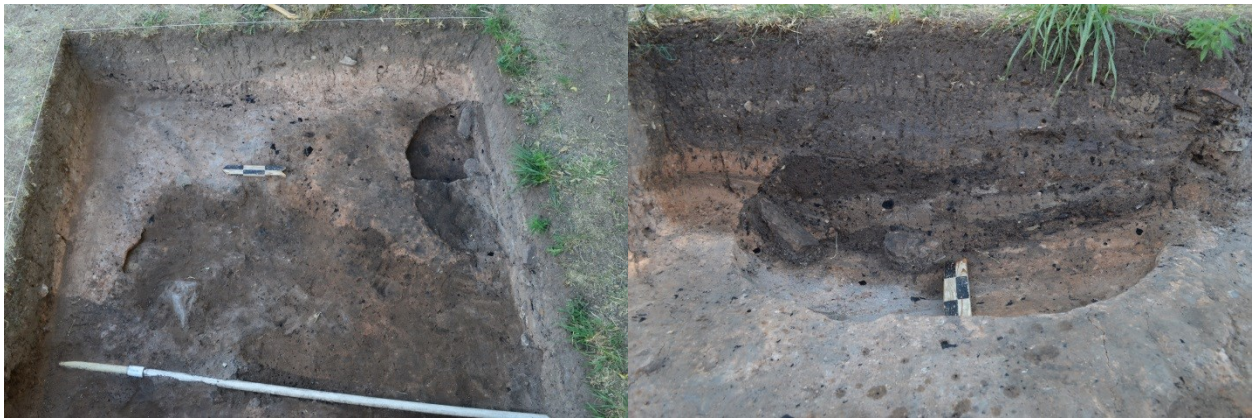
**Figure 8. Impact of mechanical disturbance on Feature 1, Nonstructure 187, oblique and profile views, the Haynie site.**

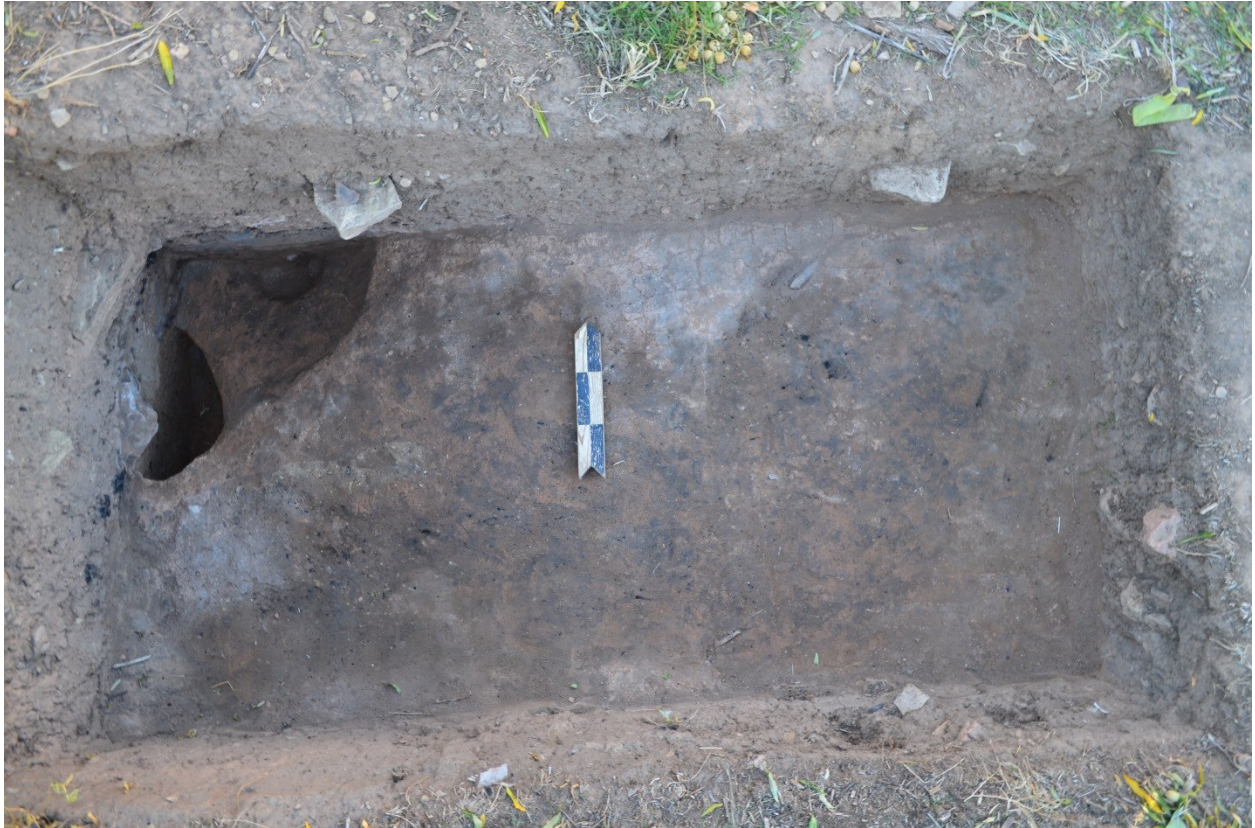
**Figure 9. Nonstructure 191 surface in a 1-x-2-m unit south of the remains of the west great house (view north), the Haynie Site.**

Nonstructure 191 is a surface identified in a 1-x-2-m unit (Figure 9) and consists of compacted native sediment beneath the west great house. As evidenced by backhoe scars, the surface and the sediment above this surface had been disturbed by previous digging in the great house. Despite the disturbance, small portions of two pits, Features 1 and 2 (Figure 10), which had been dug into undisturbed native sediment, were defined. Feature 1 is a shallow pit with a small depression. Feature 2 had been dug into Feature 1.

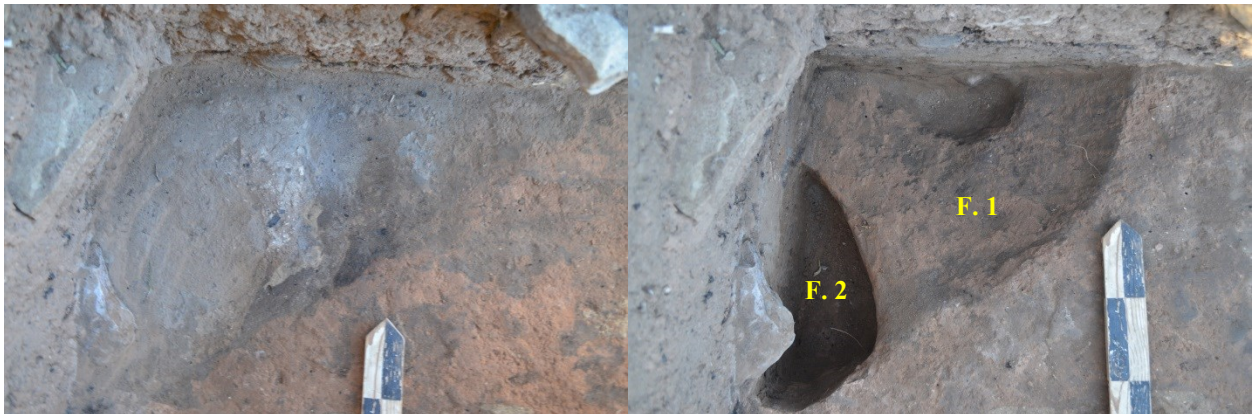
**Figure 10. Pre- and post-excitation, Features 1 and 2, Nonstructure 191 (view north) the Haynie Site.**

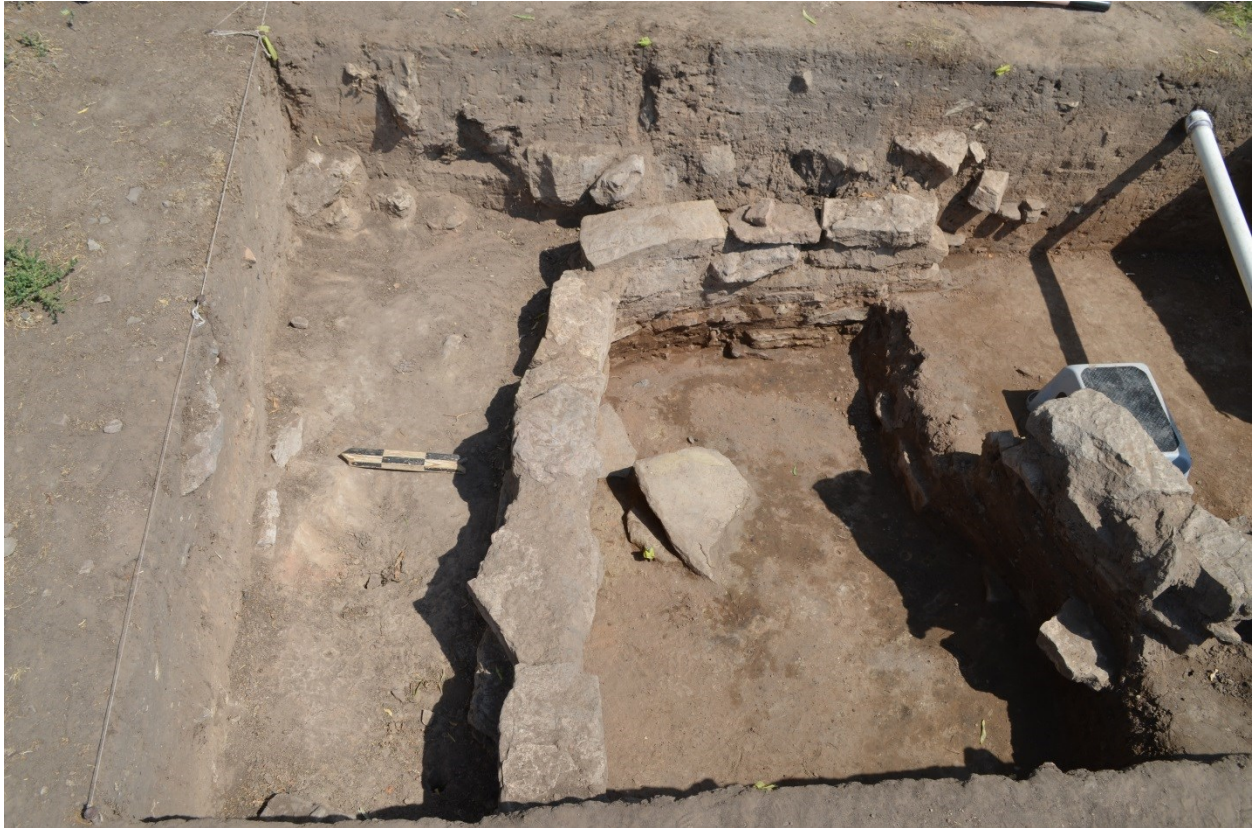
**Figure 11. Oblique view of the Structure 193 north and east wall segments (view east), the Haynie site.**

Structure 193 is a room constructed of single-coursed masonry located directly west of the modern house. The northern wall of the room was identified in two 1-x-1-m units—one was randomly selected to investigate the deposits west of the modern house, and one was selected to investigate the northern wall (Figure 5 and Figure 6). The wall consists of rectangular sandstone blocks and mortar, and the wall arcs to the southeast (Figure 11). The trajectory of the wall suggests that the interior is approximately two meters wide (east-west); the exact measurement will be revealed by excavations to the south and west in 2018. The floor was not prepared. Structure 193 experienced disturbance in both ancestral-Pueblo and modern times: Structure 186 had been constructed within Structure 193, and a laundry-drainage pipe was recently installed roughly east-west through the center of the room. The southwest portion of the room will be excavated in 2018.

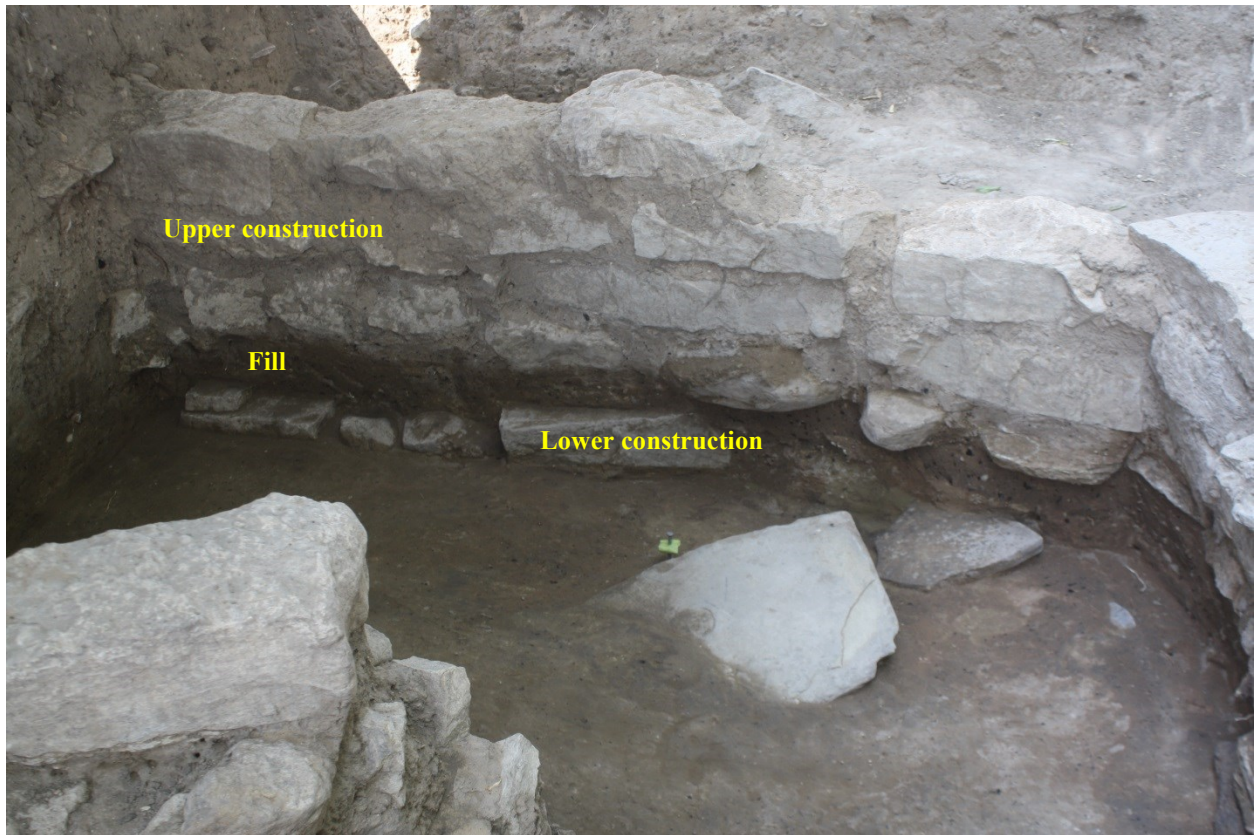
**Figure 12. The interior face of the north wall of Structure 193, the Haynie site. Note upper construction (rectangular blocks), underlying fill, and lower rock alignment.**

Beneath the upper portion of the north wall (Figure 12) is a layer of construction fill. Under this fill is an alignment of sandstone rocks. These stones appear to create an arc to the northeast rather than follow the trajectory of the upper wall. Excavations in 2018 will seek to determine if these stones represent footer construction associated with the upper portion of the wall or a different construction that predates both Structures 186 and 193.

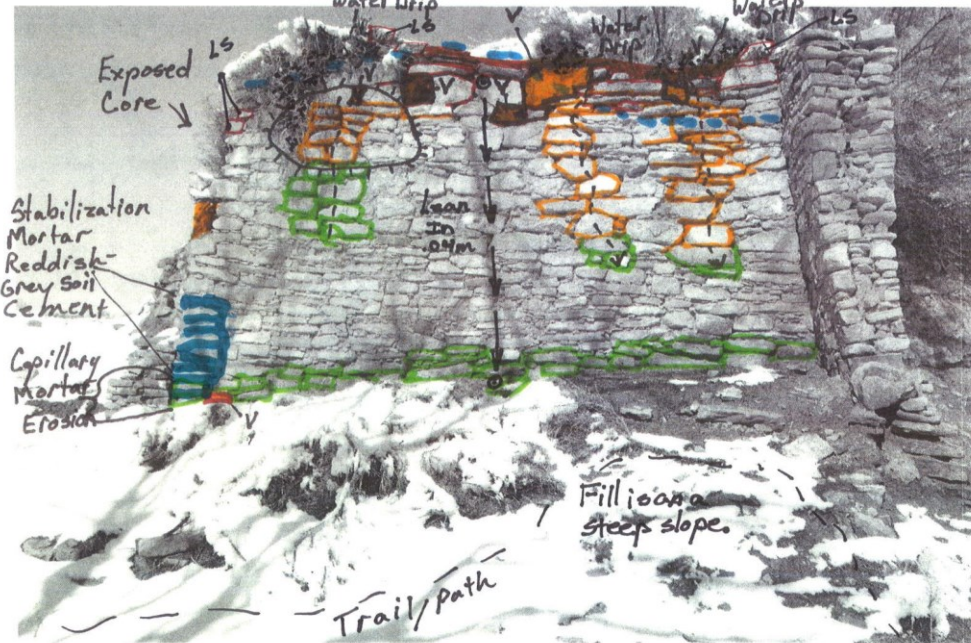
Room 163 North Interior Condition Assessment

**Cap:**  
 - Buffering from unprotected mortar etc. water entering wall. Three holes.  
 - Vegetation displacing stone.  
 - Mortar erosion moderately severe.

- No leans. No threat.
- Small veneer bulge. Low.
- No cracks. No threat.
- Moderate fill pressure from behind. Low

- Cap open and eroding and veg damage. Severe
- Loose stones in cap. Severe.
- Water runnels causing mortar erosion. Moderate
- Capillary mortar erosion along base. Severe.

**Figure 16. Condition assessment annotation for the interior face of the north wall of Room 163 in the west great house, the Haynie site.**

Crow Canyon's architectural condition assessment is derived from the Intermountain Region National Park Service Level 2 Condition Assessment procedure (Nordby et al. 2008, Vance 2015). This type of documentation has three foci: (1) discerning the historic integrity of the architecture, (2) documenting threats to the wall fabric, and (3) documenting structurally destabilizing issues. Historic integrity refers to how much of the structure is standing and how much of the standing material is original and not reconstructed during stabilization. Wall-fabric threats encompass the most common agents of deterioration including water, weather, gravity, pests, and people. Structural-integrity issues are signs that portions of a structure have the potential to collapse. These signs include holes, voids, cracks, leans, and bulges. Together, these issues create a profile of the state of deterioration of a structure (Figure 16). Condition assessment also identifies and prioritizes areas needing stabilization.

The north wall of Room 163 in the west great house is the tallest exposed masonry wall at the Haynie site. It stands 2.5 m tall, is 4.73 m long, and towers over the central rear section of the west great house, which is an area of particular interest in NCOP research. A second veneer had been added to the exterior (north) face of the wall, which makes the wall extremely robust, but leaves the top of the wall susceptible to erosion. Our condition assessment found six small to medium voids in the upper courses of the interior face and at least seven loose stones along the current cap.

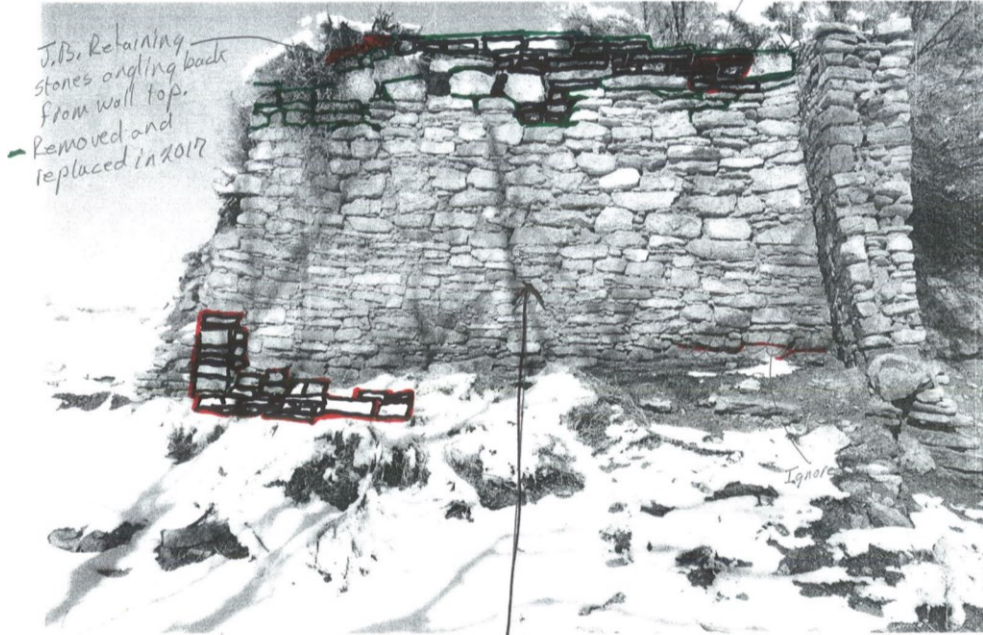
Stabilization  
Documentation

Eroded/Recessed stone  
Prior to 2017 repair.  
Possible beam socket filled  
with stab stone by  
J. Brisken?

Added Stabilization stone

Repairs  
June 2017  
S. Diederichs

Repairs  
2009-2013  
J. Brisken  
Hard pinkish brown  
soil cement with  
high sand

Original north wall added  
veneer mortar.  
Light brown compact sandy loess  
with sporadic/large charcoal  
flecking.

Figure 20. Post-stabilization annotated photograph of the interior face of the north wall of Room 163 in the west great house, the Haynie site.

In 2017, the north and east walls of Room 163 were partly capped to increase the stability of the walls. In the north wall (Figure 20), three large stones were reset, six voids were filled, two courses of stone were added to the top of the veneer, and a small section of veneer was repointed. In total, 31 stones and 12 gallons of mortar were used to stabilize the wall cap. The east wall was

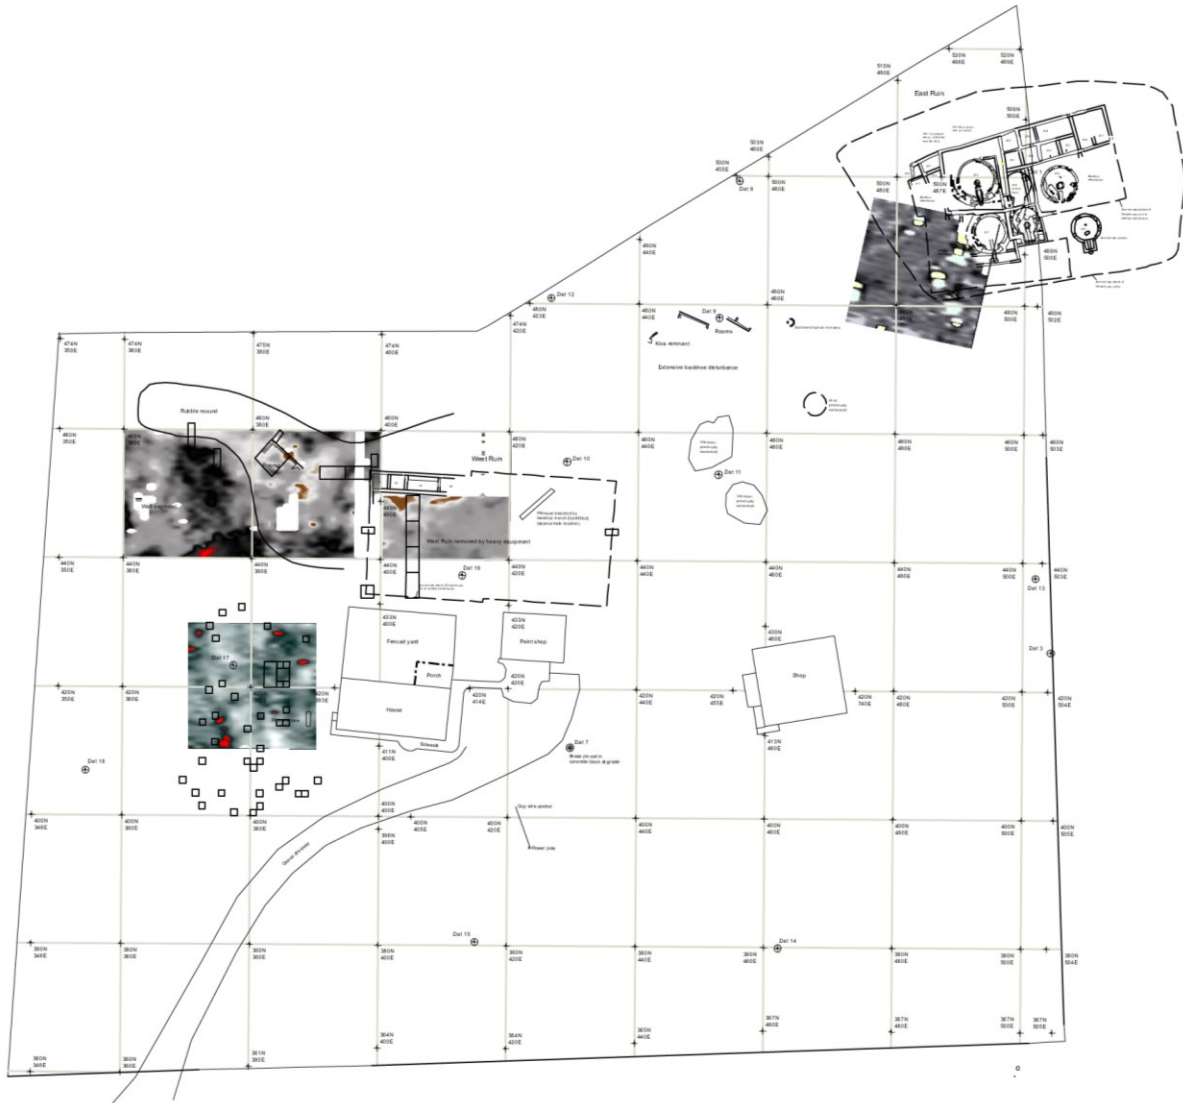
**Figure 21. Locations of geophysical grids on the Haynie site (5MT1905).**

The geophysical survey for the 2017 fieldwork was conducted with two Geoscan products: a RM15 Electrical Resistance Meter and a FM36 Fluxgate Gradiometer. Grids for the electric resistance survey were aligned to true north, whereas grids for the fluxgate gradiometer were aligned to magnetic north. At the Haynie site, the magnetic north is about 11 degrees east of true north. Each grid in both surveys measured 20-x-20 m. Five grids were surveyed with the electrical resistance meter, and one grid was surveyed with the gradiometer (Figure 21). Weather and soil conditions changed throughout the collection period but were not unusually wet or dry at the time of the surveys.

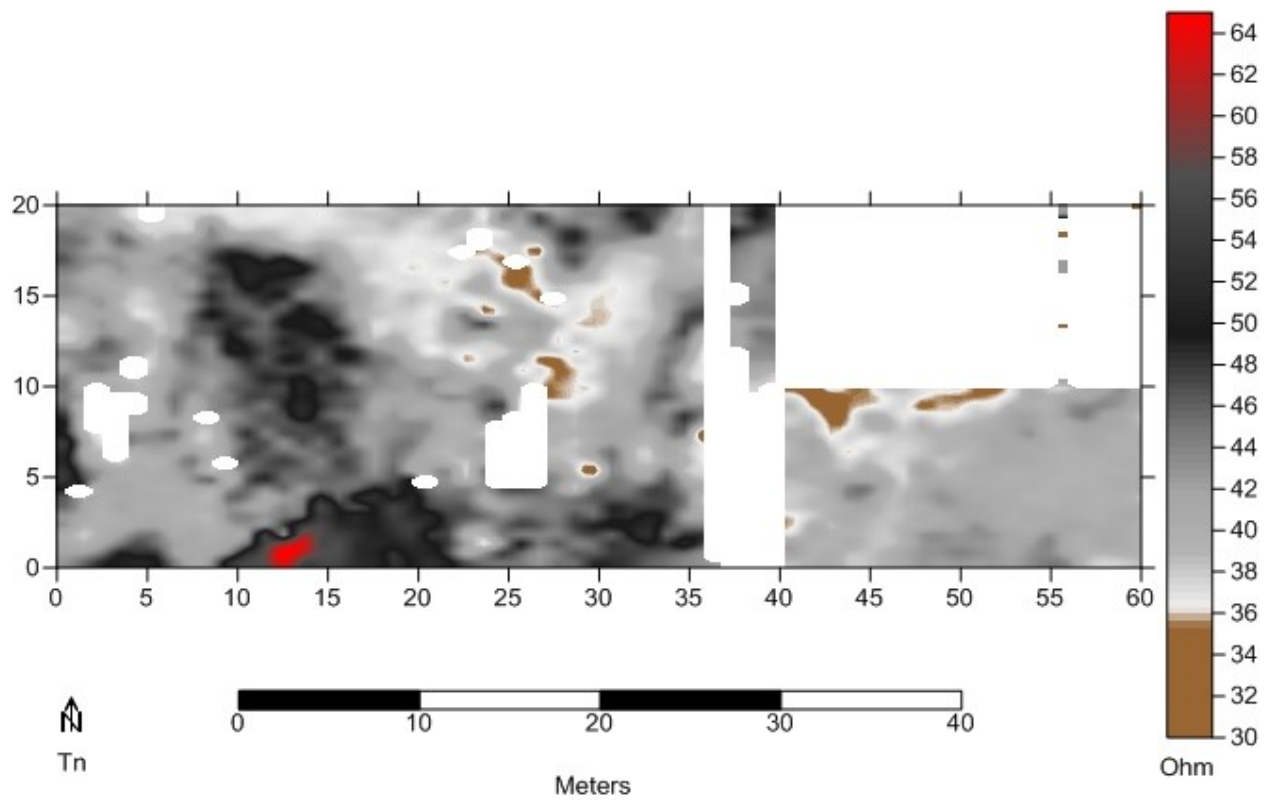
**Figure 23. Electrical resistance survey Grids 1, 2, and 3 at the Haynie site. Image created by Mona Charles, Powderhorn Research LLC, 2017.**

Electrical resistance survey works on the principle that anomalies beneath the modern ground surface can be detected because their resistance to the flow of an electrical current deviates from the surrounding norm. The survey at the Haynie site (Figure 22) measured the distortion of an induced electrical field caused by subsurface phenomena such as archaeological structures or features. Grids 1, 2, and 3 (Figure 23) encompassed an area in the northwestern portion of the site where a wall that is apparently independent of the remains of the west great house had been exposed by previous mechanical digging. In the northern portion of Grid 1, a large oval area with relatively high resistance and two specific anomalies was detected. These anomalies may represent historic or prehistoric cultural deposits. Alternatively, the anomalies may represent bedrock that is fairly deep subsurface; that is, if the bedrock was shallow, the resistance values would be much higher.

Auger testing in the two identified anomalies indicate substantial depth to the deposits (greater than 1.5 m), and subsequent test trenching indicates the presence of possible structures that might have been impacted by mechanical digging and the modern occupation of the site. An aboveground water line that fed a sprinkler system was removed from the area just south of Grids 1 and 2. The resistance data did not show any clear effect from this water line. Because of extensive previous digging and the necessity to dummy-log large portions of the grids, Grids 2 and 3 did not yield definitive data.

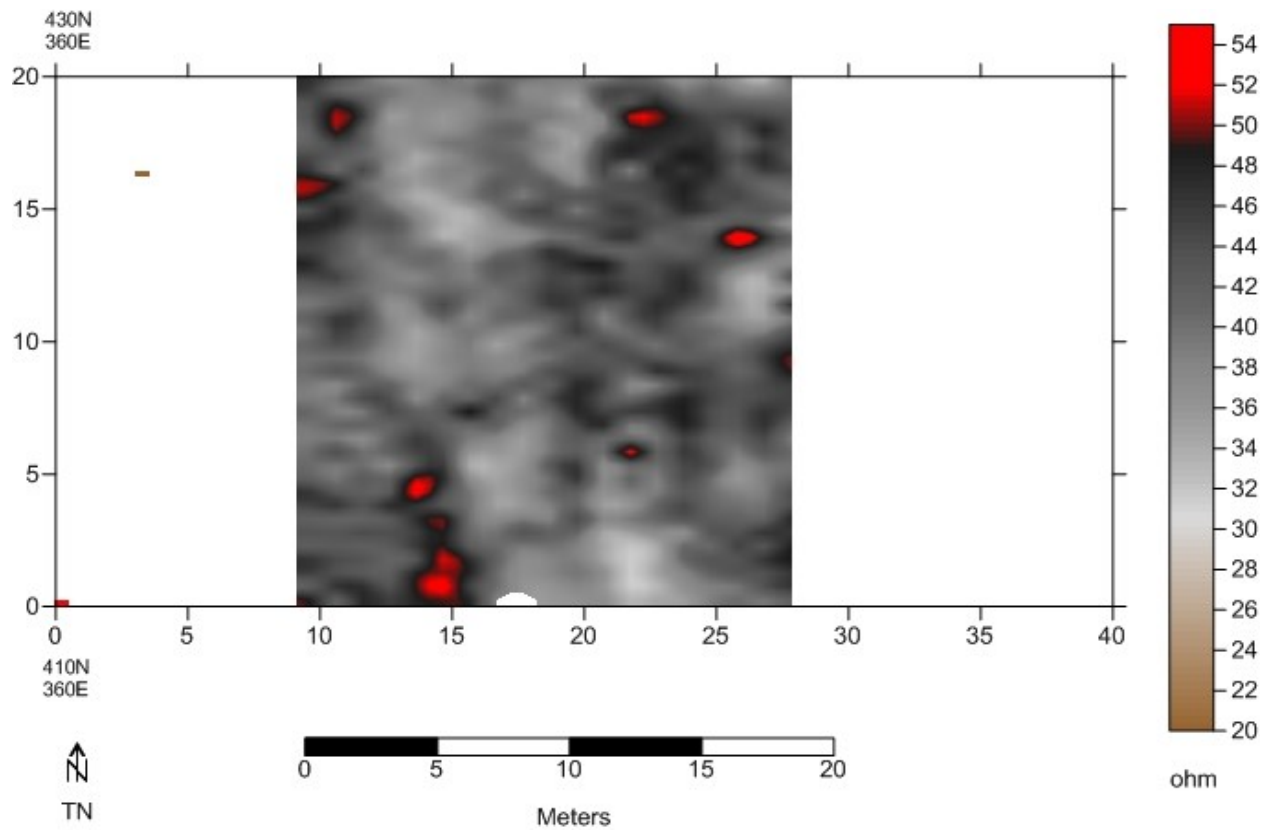
**Figure 24. Electrical resistance survey Grids 4 and 5, the Haynie site. Image created by Mona Charles, Powderhorn Research LLC, 2017.**

Grids 4 and 5 (Figure 24) were located southwest of the west great house primarily in the area of the lawn that had been created after the area was leveled for the modern house; sediments from the west great house were used for that leveling. The resulting data indicate several potential anomalies in the northern and eastern portions of the surveyed area. Whether these anomalies represent undisturbed prehistoric features requires verification with either a different method of remote sensing or with excavation. Excavations in Grid 5 revealed that linear anomalies in the electrical resistance data represent intact ancestral Pueblo walls of potentially three superimposed structures that may predate the great houses (see Structures 186 and 193).

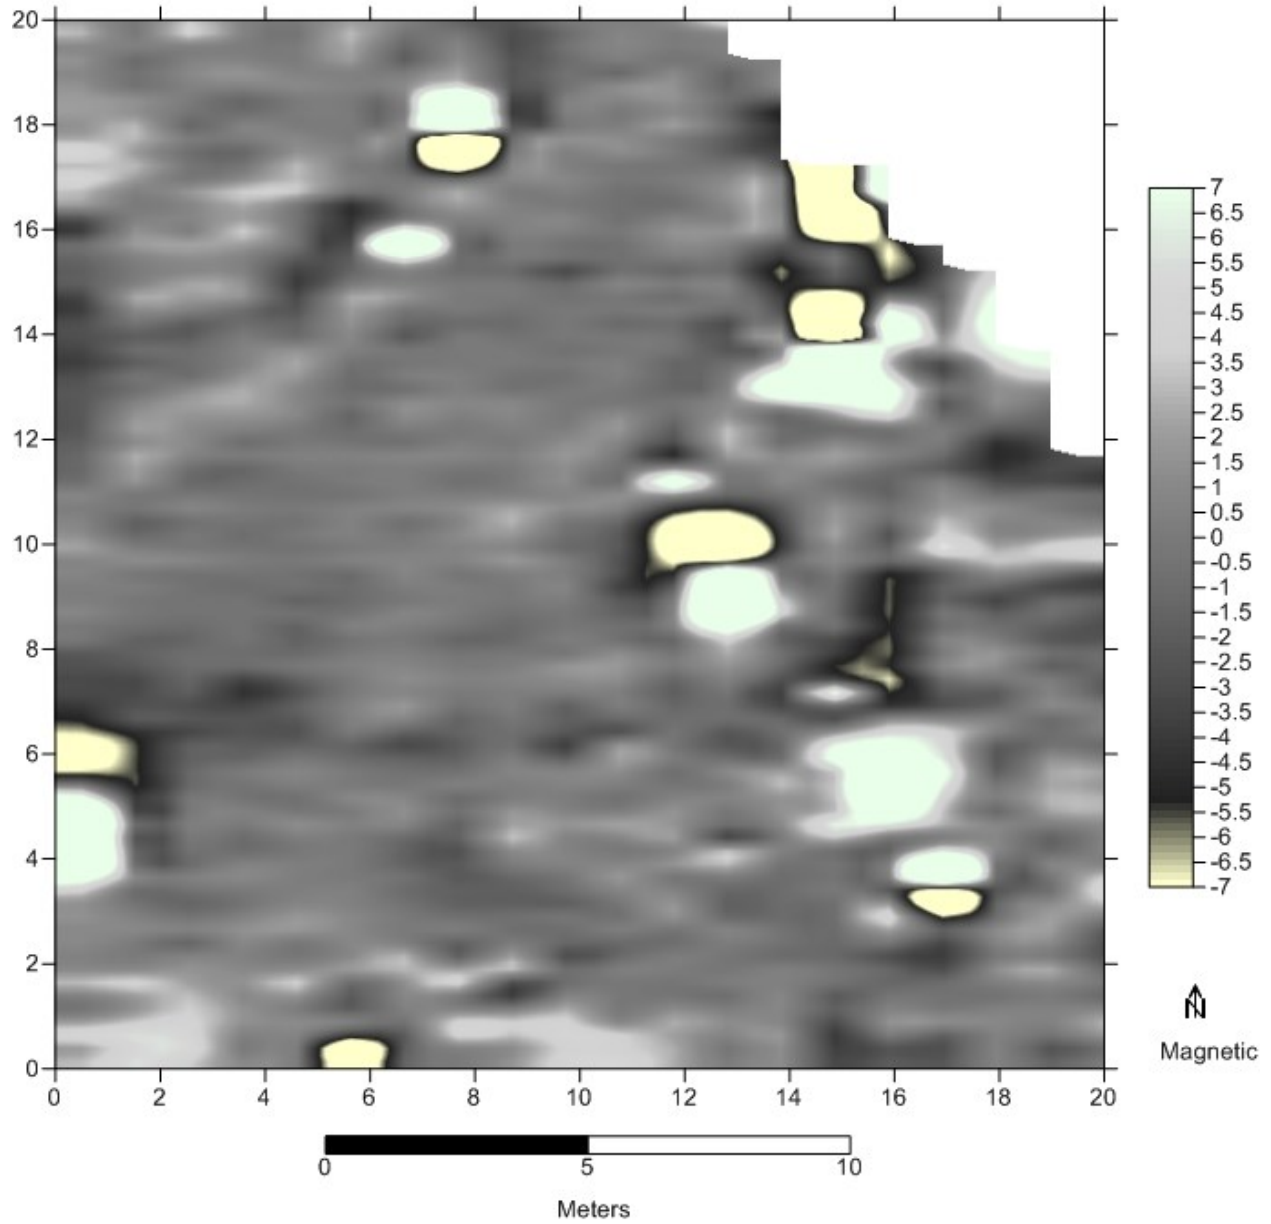
**Figure 26. Gradiometer survey Grid 1, the Haynie site. Image created by Mona Charles, Powderhorn Research LLC, 2017.**

One grid just southwest of the east great house was surveyed with a gradiometer (Figure 25). This instrument works on the principle that buried artifacts, features, or differences in sediments and soils produce minute variations in the earth's magnetic field. The gradiometer measures the strength of the earth's magnetic field in different locations and records variations in those values. The gradiometer survey isolated at least two linear anomalies—one that extends east-west across the bottom of the grid, and another that is oriented diagonally in the northwest corner of the grid (Figure 26). The east-west linear anomaly follows the basic outline of the great house as illustrated on a map produced before the east great house was damaged in modern times (Figure 15). The diagonal anomaly in the northwest corner of the grid projects toward the northwest corner of the east great house and the northwesternmost kiva (Figure 21) in that great house. This anomaly may indicate a buried prehistoric feature related either to the great house or to an earlier occupation. Alternatively, the linear anomalies could be reflect one or more activities that occurred during previous digging in this portion of the great house such as historic pedestrian paths, wheelbarrow paths, or heavy equipment paths, or even indicate buried utility lines. Additional testing of this area will occur in the 2018 and 2019 field seasons.
